REVISION 1
TO
KWM/HF-380 SERVICE BULLETIN NO 7

KWM-380 TRANSCEIVER (622-5093-001, -101)
HF-380 TRANSCEIVER (622-3580-001, -101)
CONTROL CARD A8 (638-6929-001, -002)

SERVICE BULLETIN NO 7**PREVENT EXCESSIVE EMI (RCVR BIRDIES) AND
ELIMINATE ELECTRONIC TUNING BACKLASH**

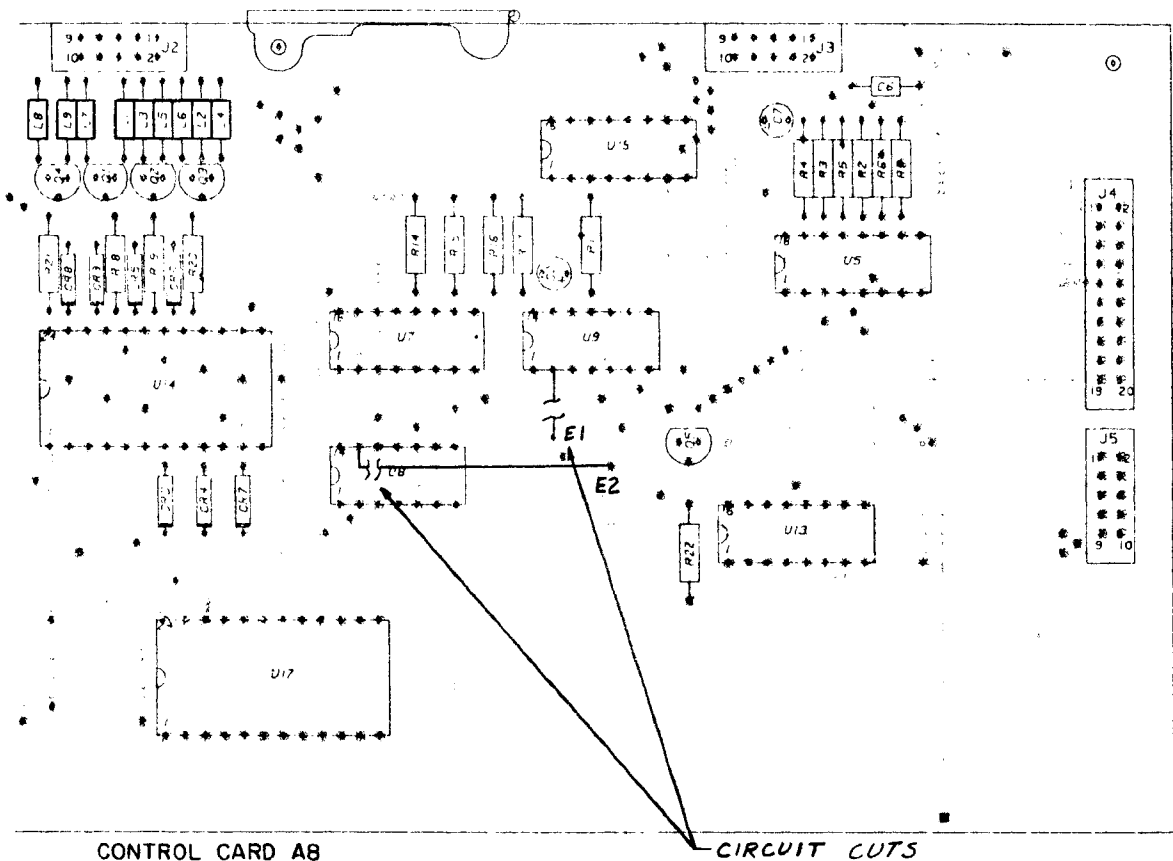
P/O Control Card A8
Figure 1

Some of the HF-380 and KWM-380 Transceivers have exhibited excessive electromagnetic interference (birdies) in the 4- to 5-MHz frequency range and on certain frequencies that repeat on every band such as 7.259, 14.259, etc. This problem is solved by changing the values of nine coils in the control card A8 output to the low-pass filter and by adding cable clamps to properly position two cables in the synthesizer compartment.

- E. Remove 100- μ H coils L1 through L9 and replace them with 560- μ H coils (240-2723-050).
- F. Cut the circuit trace from U9-2 to E1.
- G. Cut the circuit trace from U8-13 to E2.
- H. On the bottom of the card, install a jumper wire (422-2400-020) from E1 to U9-4.
- I. On the bottom of the card, install a jumper wire (422-2400-020) from E2 to U8-12.
- J. Install two cable clamps (150-0873-010) in the synthesizer compartment as shown in figure 2.
- K. Route the two cables on the back of the synthesizer assembly through the cable clamps and out the end of the card cage. This will hold the cables away from the circuit card components.
- L. Reassemble the transceiver in the reverse order of disassembly.

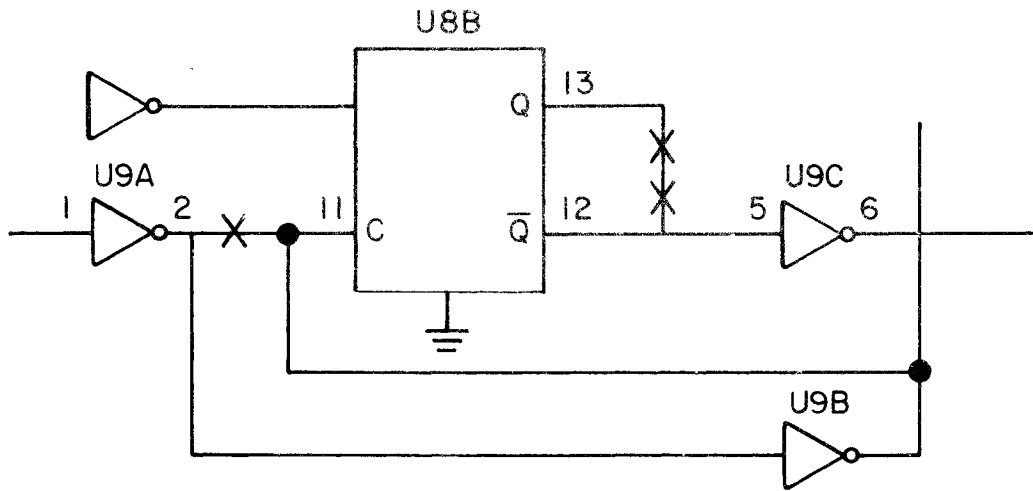
P/O Control Cable A8, Schematic Diagram
Figure 3

At times, when moving the tuning knob in the opposite direction of its previous rotation, the frequency will go one count in the wrong direction before tuning properly. An example would be tuning up in frequency, stopping, then tuning down in frequency. The display may go up one additional count before starting down. This electronic backlash is eliminated by this modification which consists of making two circuit trace cuts and adding two jumper wires.
