HF-380 TRANSCEIVER (622-3580-001)
KWM-380 TRANSCEIVER (622-5093-001)
RECEIVER-EXCITER ASSEMBLY A3 (638-6908-001, -002)

SERVICE BULLETIN NO 13

AGC TIME CONSTANT CHANGES

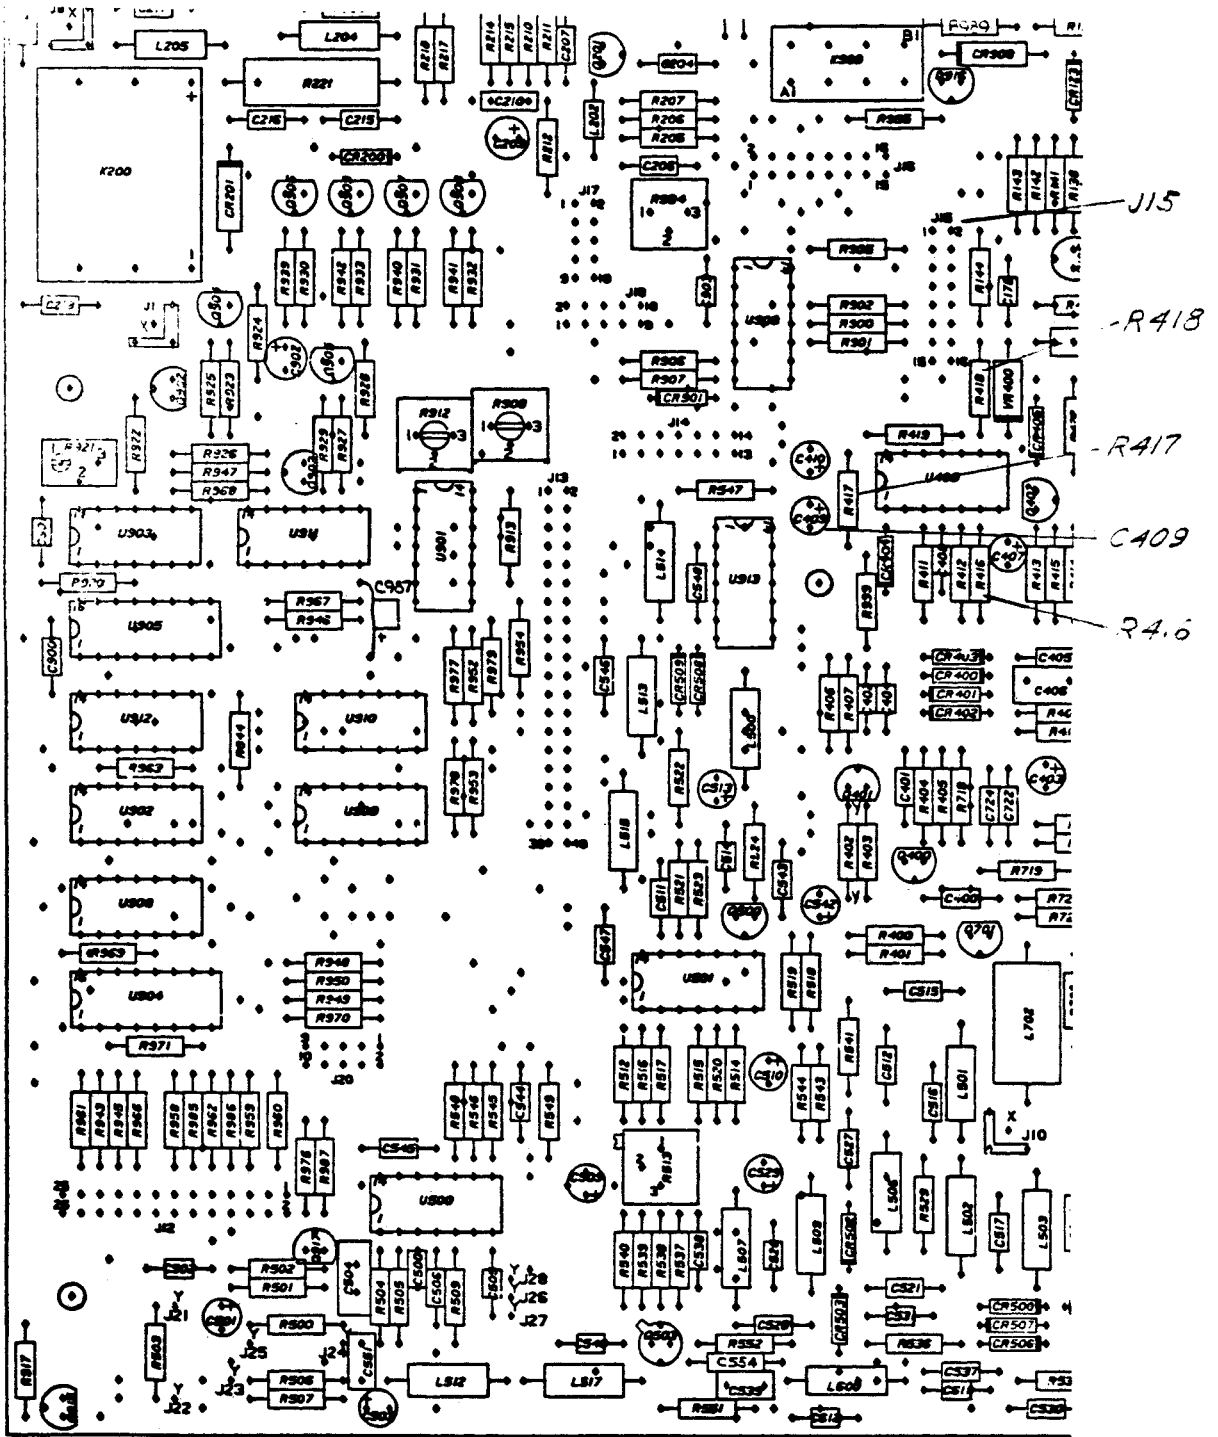
P/O Receiver-Exciter Assembly A3
Figure 1

This change is accomplished by changing the values of three resistors and one capacitor on receiver-exciter assembly A3.

- D. Disconnect the cable connected to J15.
- E. Remove 3.3- μ F capacitor C409 and replace it with a new 1.0 μ -F capacitor (184-9102-350).
- F. Remove 2.2-M Ω resistor R416 and replace it with a new 3.3-M Ω resistor (745-0875-000).
- G. Remove 910- Ω resistor R417 and replace it with a new 2.7-k Ω resistor (745-0764-000).
- H. Remove 27-k Ω resistor R418 and replace it with a new 2.7-k Ω resistor (745-0764-000).
- I. Reconnect the cable that was removed from J15 in step D.
- J. Reinstall the dust cover.
- K. Mark SB 13 on the service bulletin information chart. If the transceiver does not have an information chart (280-3778-010), order one and attach it near the nameplate.
