# SERVICE BULLETIN

KWM-380 TRANSCEIVER (622-5093-001)  
HF-380 TRANSCEIVER (622-3580-001)  
RECEIVER-EXCITER ASSEMBLY A3 (638-6908-002)

## SERVICE BULLETIN NO 14

### TRANSMIT AUDIO FREQUENCY RESPONSE AND MIC CARRIER CONTROL NOISE

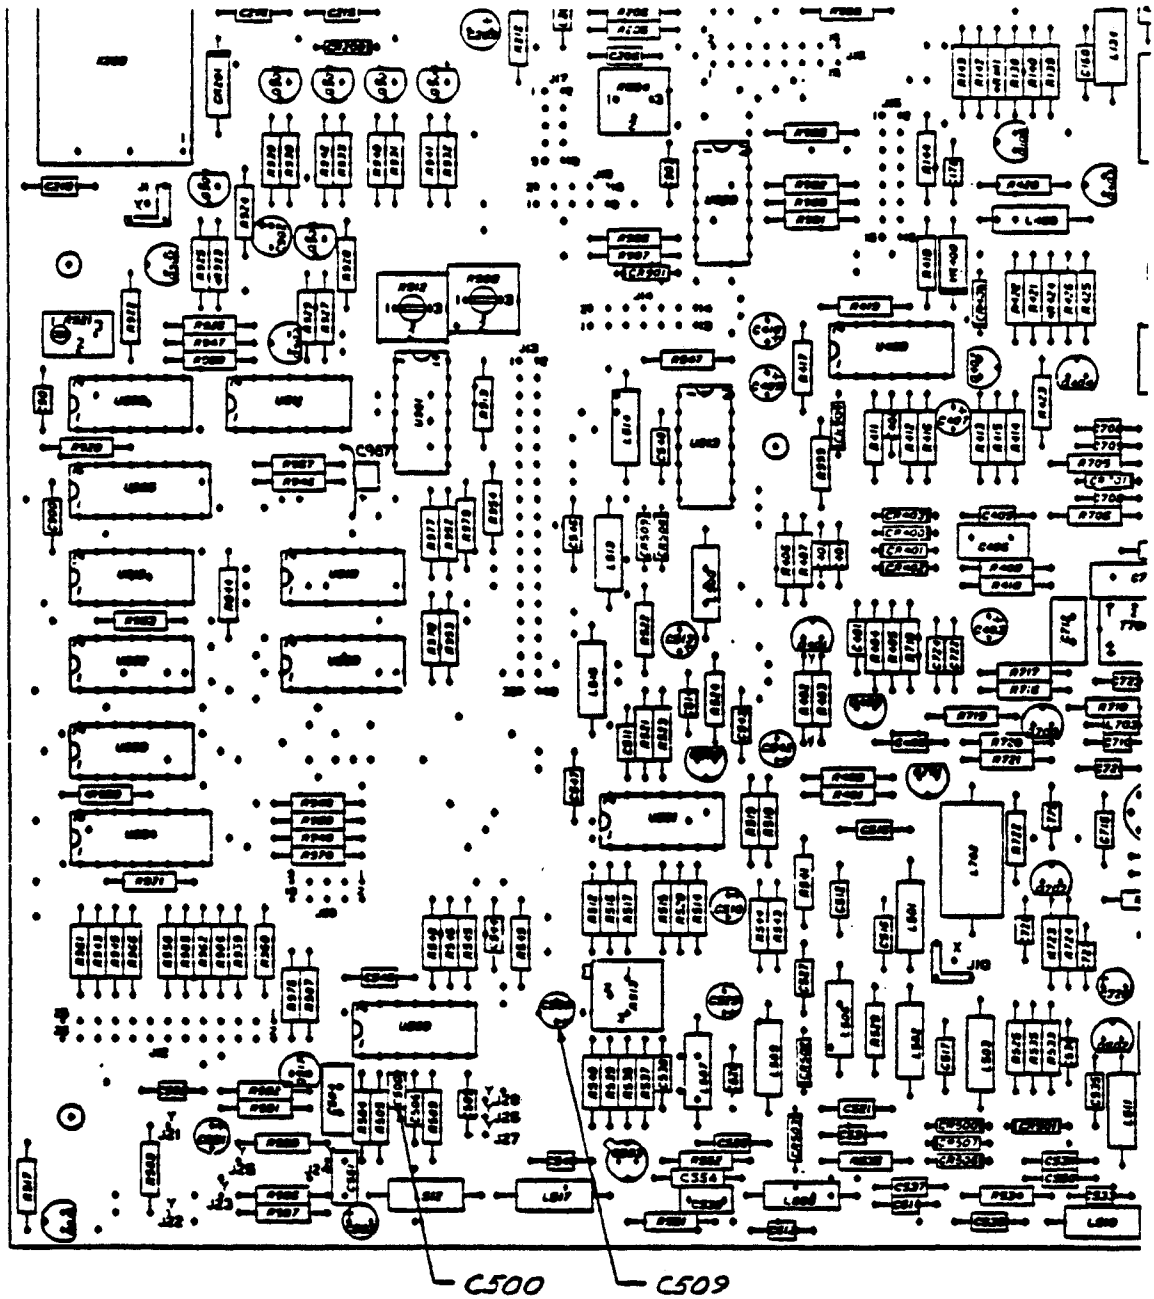
P/O Receiver-Exciter Assembly A3  
Figure 1

**NOTE:** Refer to figure 1 for location of C500 and C509.

- D. Remove 470-pF capacitor C500 and replace it with a 2200-pF capacitor (913-5019-120).
- E. Remove 1- $\mu$ F capacitor C509 and replace it with a 4.7- $\mu$ F capacitor (184-9102-390).

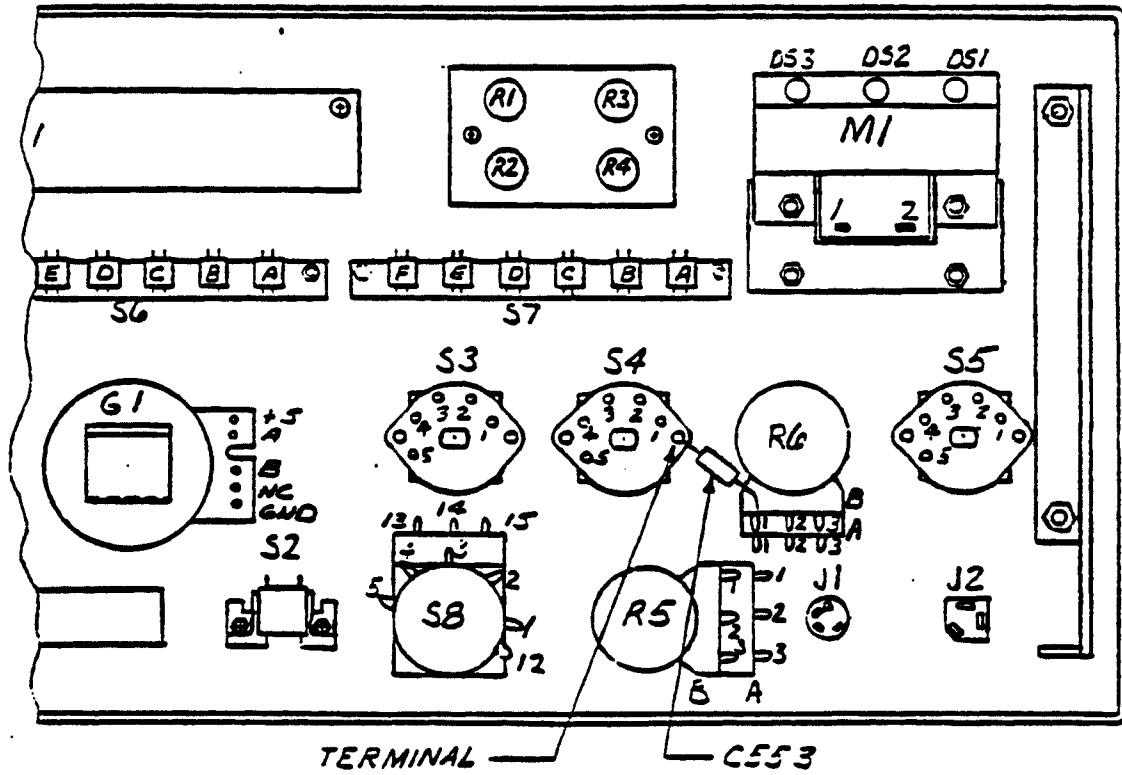
P/O Front Panel Assembly A10  
Figure 2

**NOTE:** Refer to figure 2 while performing steps F through H. Capacitor C553 is part of receiver-exciter assembly A3 but is mounted on front panel assembly A10. If C553 were mounted on the A3 card, a circuit trace cut on the bottom of the card would be required making it necessary to remove the card from the radio. Refer to figure 3 for a schematic diagram which shows the location of C553.

- F. Install an insulated terminal (306-1018-000) on the S4 mounting screw nearest potentiometer R6. If not enough threads are available, remove the nut.
- G. At R6B-1, remove the white wire and reconnect it to the new terminal installed in step F.

- H. Install 0.1- $\mu$ F capacitor C553 (913-3331-030) from the new terminal to R6B-1.
- I. Solder and check all new connections.
- J. Perform the following passband tuning oscillator alignment:

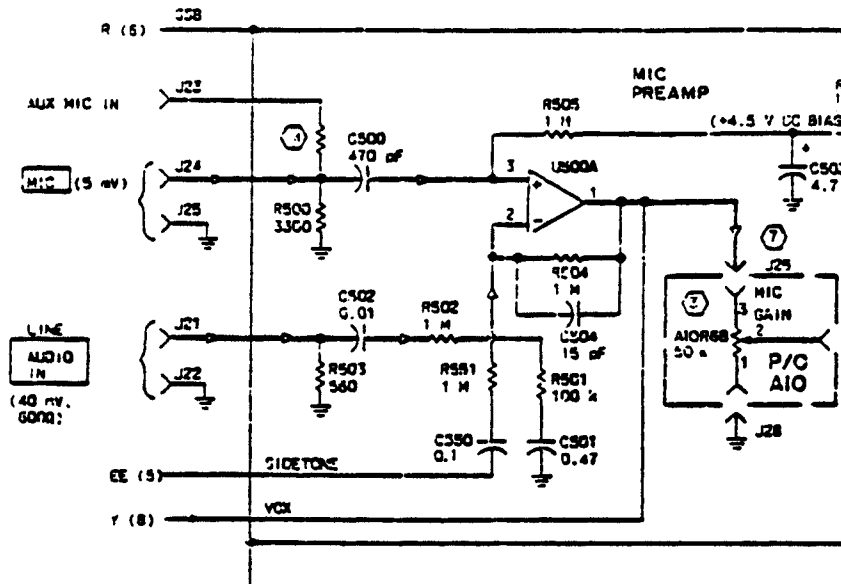
BEFORE MODIFICATION

When the mic carrier control is rotated, it may produce noise in the transmit audio output. This modification adds a dc blocking capacitor in series with the top of the mic carrier control potentiometer to prevent noise generation.

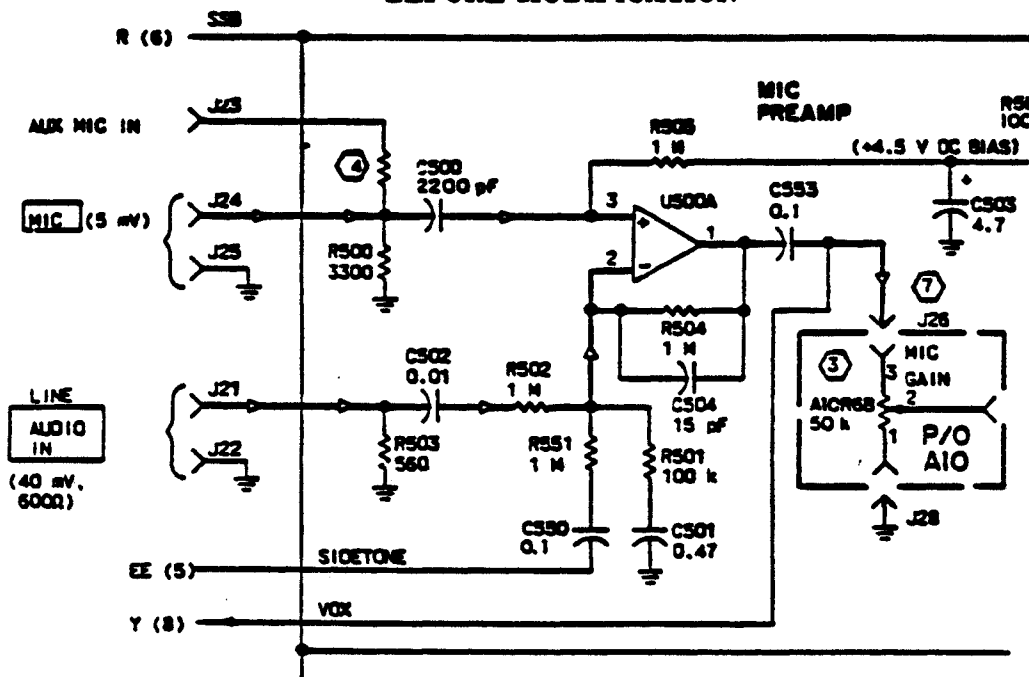
AFTER MODIFICATION

P/O Receiver-Exciter Assembly A3,  
Schematic Diagram  
Figure 3
