CHANGE 1 TO KWM-380/HF-380 SERVICE BULLETIN NO 9

KWM-380 TRANSCEIVER (622-5093-001, -101)
HF-380 TRANSCEIVER (622-3580-001, -101)
POWER AMPLIFIER/HEAT SINK ASSEMBLY A1 (634-8481-003)
POWER AMPLIFIER CIRCUIT CARD ASSEMBLY A1A1 (638-6775-001)

SERVICE BULLETIN NO 9

STOP PA OSCILLATIONS AND ADJUST CIRCUIT GAIN

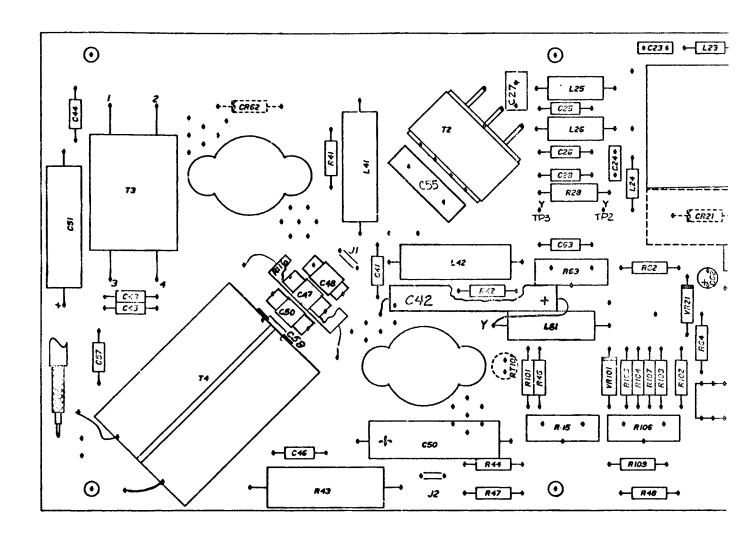
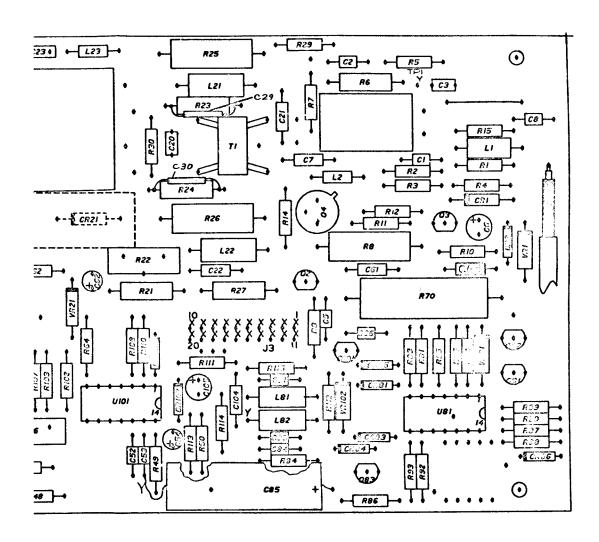
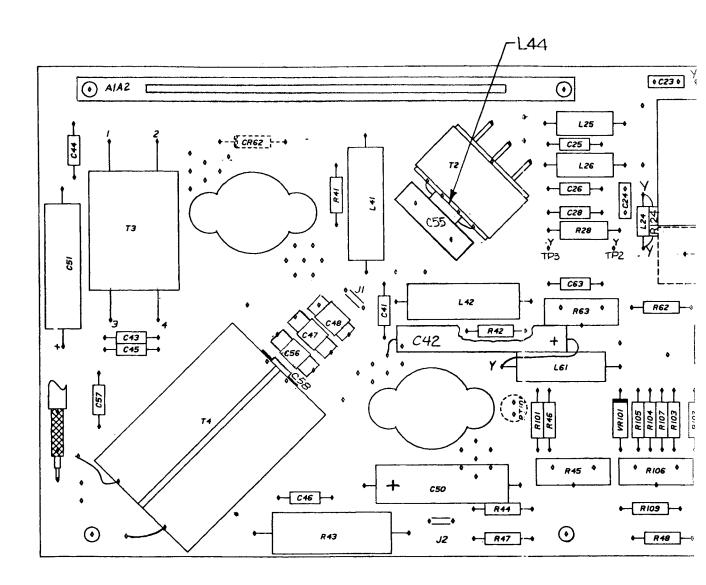
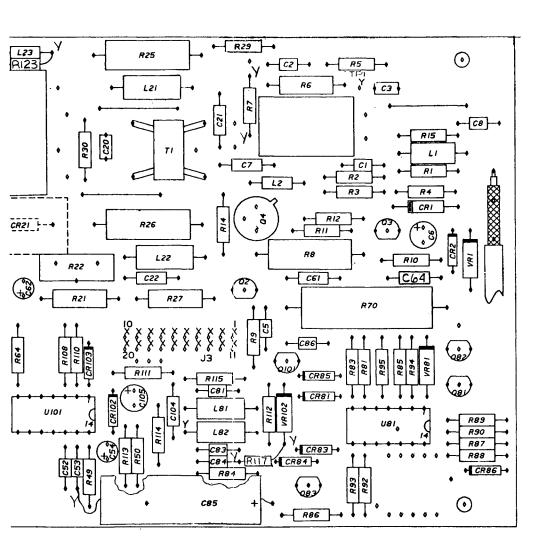
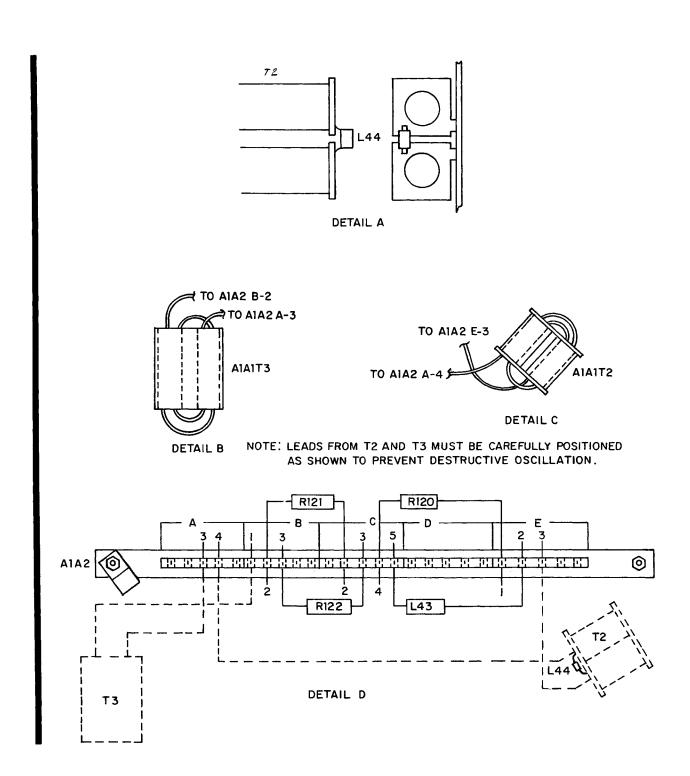
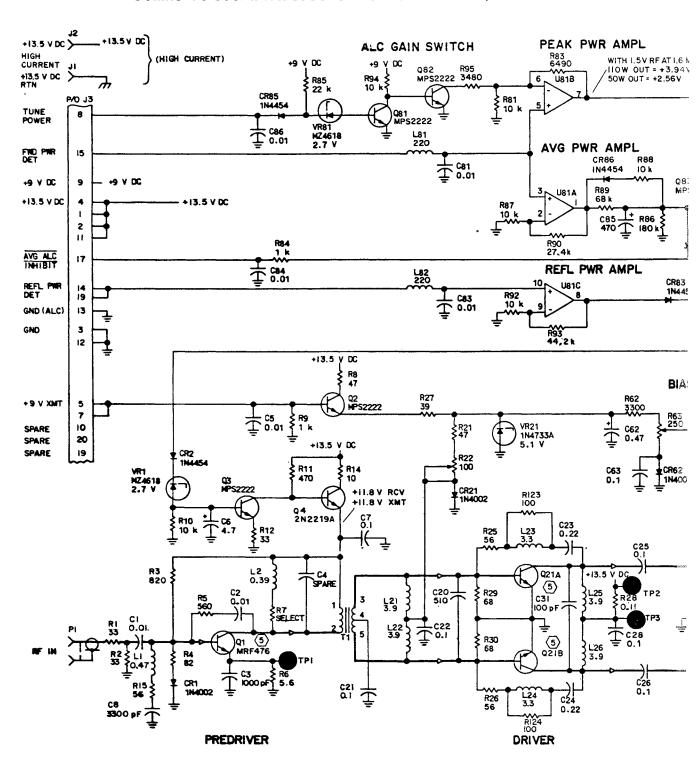
- 1. Power amplifier oscillations at 0.5 MHz are stopped by adding feedback. The oscillations can be detected by observing higher than normal reflected power when transmitting into an antenna on 21- or 28-MHz bands.
- 2. Power amplifier oscillations at miscellaneous frequencies, due to high vswr, are stopped by making miscellaneous component changes.

3. Circuit gain can vary due to transistor parameter variations between vendors. This problem is solved by selecting the value of resistor R7 to match the selected vendor for Q41 at time of installation.

- NOTE: Do not remove circuit card A1A1 from power amplifier/heat sink assembly A1. Refer to figure 1 while performing steps E through T. Refer to figure 2 for a schematic diagram of the latest configuration.

- G. Install a $2.7-\mu H$ coil L44 (240-2715-180) as shown in figure 1, detail A.
- H. Remove 0.27- μ H inductors L23 and L24 by cutting the leads close to the component body. Leave the inductor leads soldered into the circuit card.

- Q. Remove and discard $68-\Omega$ resistor R116.
- R. Install electronic components assembly A1A2 (647-2781-001) onto the circuit card as shown in figure 1 using the existing hardware.

- S. Wind two turns of brown wire (422-0795-000) in transformer T3 as shown in figure 1, detail B. Connect to A1A2 assembly as shown in figure 1, detail D. If the transformer core has potting in the holes, carefully clear a way for the brown wire, using a stiff wire such as a straightened paper clip.

- T. Wind two turns of red wire (442-0796-000) in transformer T2 as shown in figure 1, detail D. If necessary, clear the core of potting as in step S.
 - NOTE: The added wires in steps S and T must be oriented as shown in figure 1, details B and C, to prevent oscillation.
