KWM-380 TRANSCEIVER (622-5093-001, -101)
HF-380 TRANSCEIVER (622-3580-001, -101)
SYNTHESIZER A5A1 (638-6916-001, -002)

SERVICE BULLETIN NO 2**IMPROVE TRANSMITTER SPECTRAL PURITY**

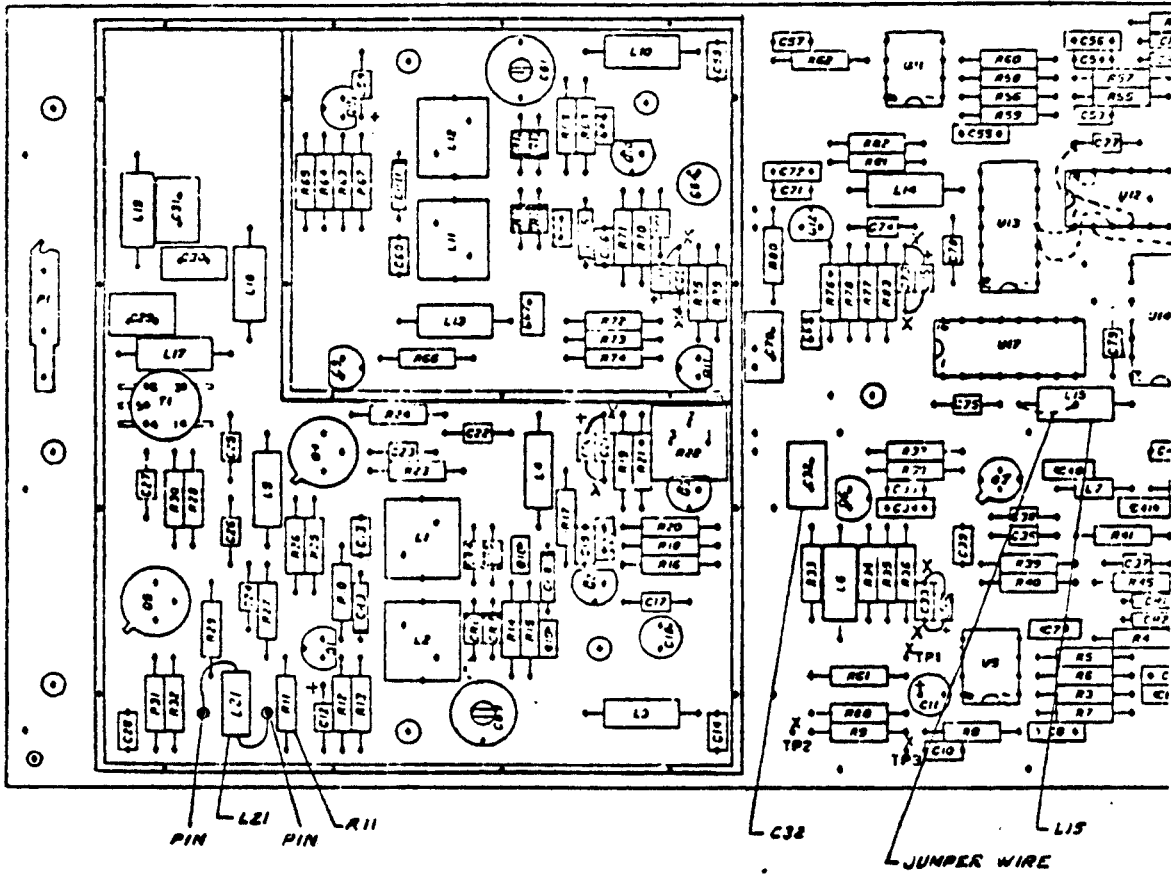
Figure 1

The purpose of this modification is to improve transmitter spectral purity when operating on a frequency ending in 257 kHz (ie 14, 257 kHz). This ensures that transmitter spurious output will be within the -50 dB specification limit.

P/O Synthesizer Card A5A1 (638-6916-001)

- D. Remove the shield cover from A5A1 card (638-6916-001, -002) by removing 19 screws.
- E. Remove A5A1 from A5 assembly by removing seven screws.
- F. On the top of A5A1, cut circuit trace at right lead of coil L15.

- G. On top of card, cut circuit trace located between thru holes where two new pins are shown in figures 1 and 2.
- H. From the top of the card, insert pins (372-2656-130) into two thru holes as shown in figures 1 and 2.

- I. Connect 4.7- μ H coil (240-1576-000) between the two new pins. Use sleeving (152-2483-000) on L21 leads if needed.
- J. Remove the 27-pF capacitor C32 and replace it with an 18-pF capacitor (913-1098-030).

- K. On the bottom of the card, install a jumper wire (428-0282-050) from the left lead of L15 to the thru hole located under L15.
- L. Mark RWK REV G on the card near the part number.
